JULY
2018

Millennium Water Alliance-Ethiopia Program Ex-Post Evaluation

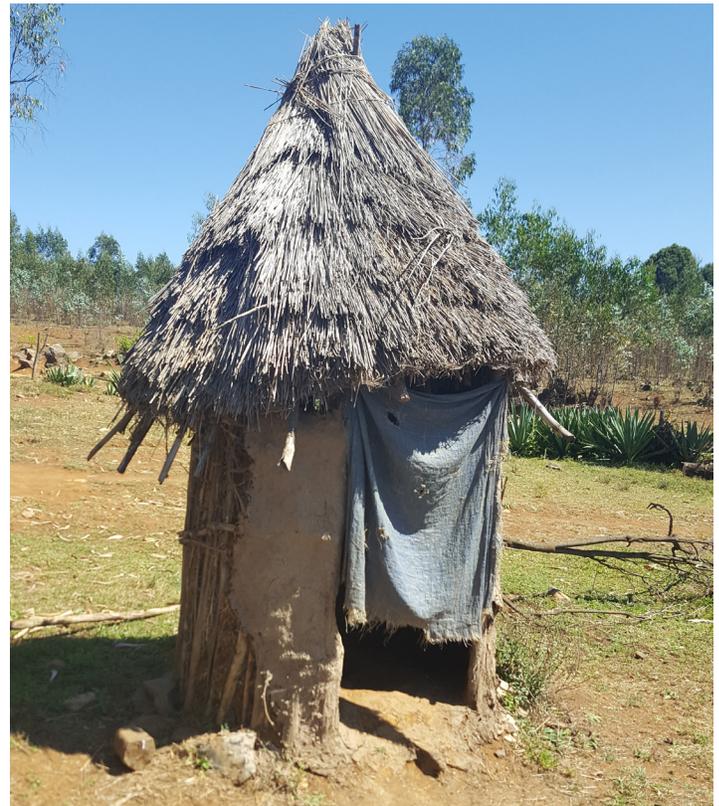
Many of the household latrines observed during this evaluation had not progressed up the sanitation ladder. Photo credit: Kari Nelson/ Water CKM Project

Household sanitation: Households are not upgrading to better latrines, even as they replace them, and overall use is inconsistent. Coverage rates appear to have been sustained, but many of the original latrines still in use, and those built to replace them, are not maintained, resulting in a lack of privacy and potential safety concerns, both factors that discourage use. Despite education on the importance of latrines, usage lags behind latrine construction and appears to be less widespread than people report, according to both observation data and interviews with Health Extension Workers (HEWs).

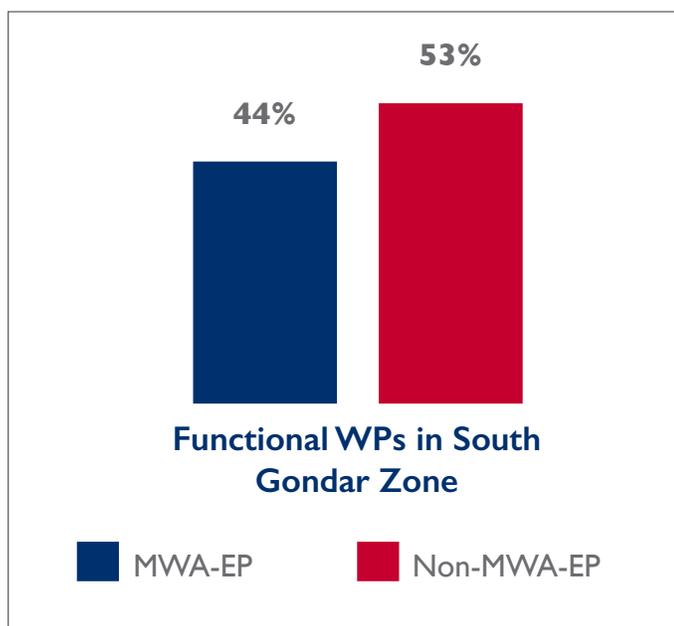
Figure 1: Comparison of MWA-EP and Non-MWA-EP water points in South Gondar Zone, Amhara

dataset representing 4,352 WPs in the Amhara region showed that only 44 percent of MWA-EP-established WPs functioned as of 2016 (see Figure 1).² WPs constructed during the same period by other implementers/organizations functioned at a rate of 53 percent, suggesting that the MWA-EP water points may be underperforming compared to other rural water infrastructure in the area.

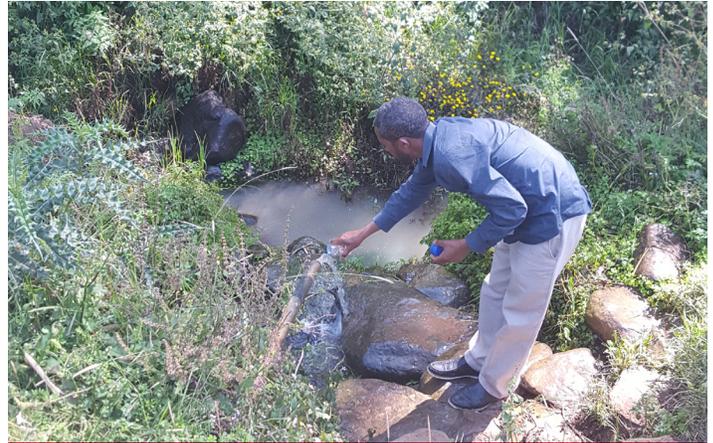
Water quantity and quality: WPs appeared to be well-used, and most produced sufficient quantities of water. However, most people continue to rely on multiple water sources. Community members used MWA-EP water points daily, when functional, particularly for drinking water. At six of nine visited WPs, flow rates were theoretically sufficient to provide water for domestic uses. In addition, most WPs failed to meet water quality standards. Despite people's beliefs that the MWA-EP water points provide clean drinking water, the majority of WPs (seven out of 10) tested positive for *Escherichia coli* (*E. coli*), and testing appeared to occur infrequently.

Evaluators found *E. coli* contamination at the majority of water points they tested. Photo credit: Kari Nelson/Water CKM Project

5. Seek stronger, more consistent alternatives to simple education-based behavior change approaches in areas with poor sanitation and hygiene norms.
6. Improve people's understanding and appreciation of water quality.
7. Address land tenure issues during activity design and throughout implementation.
