CLIMATE-RESILIENT WATER INFRASTRUCTURE:

GUIDELINES AND LESSONS FROM THE USAID BE SECURE PROJECT

March 17, 2017

This publication was produced for review by the United States Agency for International Development. It was prepared by AECOM.

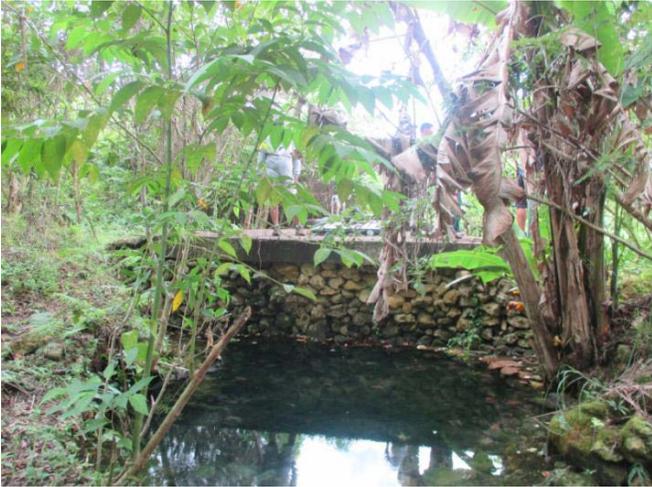
<p>Vulnerable Raw Water Source</p> <p>Manlinao Spring is one of the sources of raw water of Metro Hilongos Water District.</p> <p>The spring eye discharges into an open pond before water flows by gravity into a concrete spring box.</p> <p>During storm events, runoff water finds its way to the pond, making the water too turbid for the filter plant.</p>

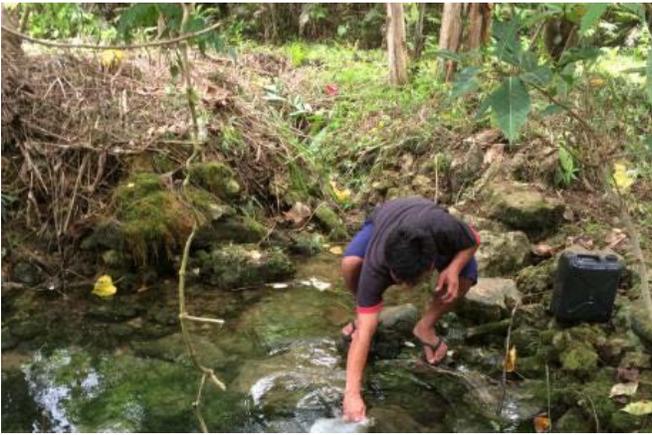
<p>Local residents also fetch water from the pond.</p>

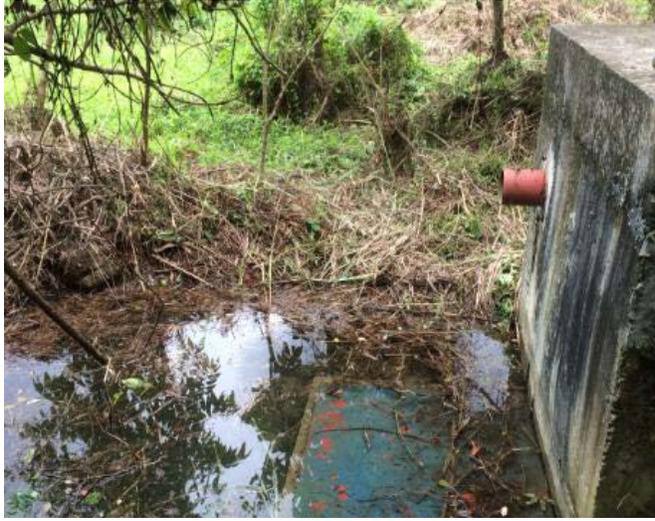
The open spring pond is vulnerable to pollution and vandalism.

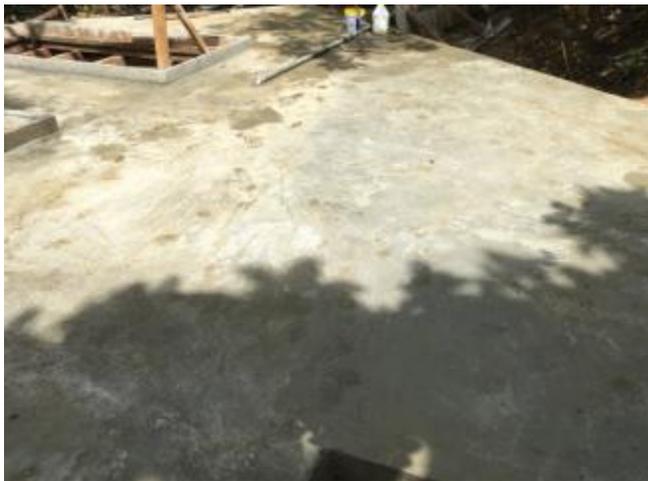
The exposed spring pond was enclosed with a reinforced concrete structure to prevent surface runoff from contaminating the water of the spring pond.

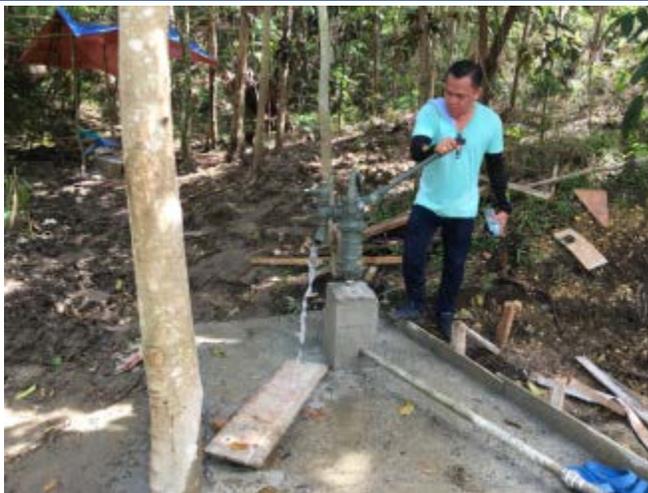
To allow local residents continued access to the spring pond, a hand pump was installed.

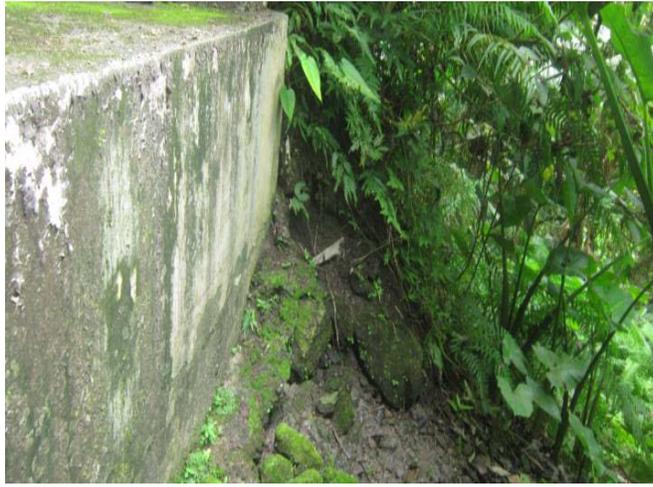
Vulnerable Raw Water Source

Water source No. 1 of Kananga LGU Water System comes from a spring box. Signs of leakage were found around the spring box. During summer, flow from the spring box is very low due to limited rain and exacerbated by the loss of water from the leaks.

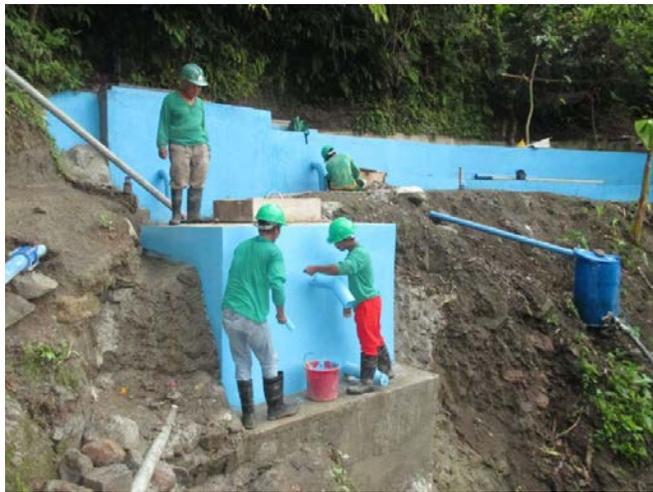
During rehabilitation, Be Secure sealed the leaks in the spring box. An additional spring box was constructed to capture excess water during the rainy season to provide continuous supply during drier periods.

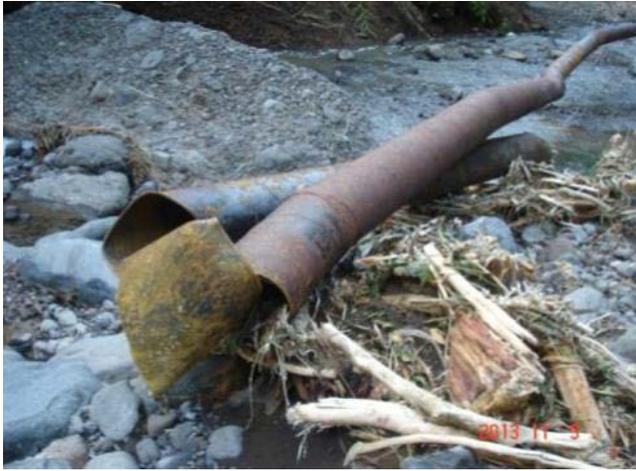
<p>Damaged Transmission Pipe</p> <p>Baybay City Water District depends on a transmission pipe that brings water from the Busay River to many communities.</p> <p>Approximately 700 m of pipeline was damaged by flooding and landslide debris during Typhoon Yolanda.</p> <p>The damage disrupted the delivery of water, which was especially needed during the post-Yolanda emergency response and recovery period.</p>

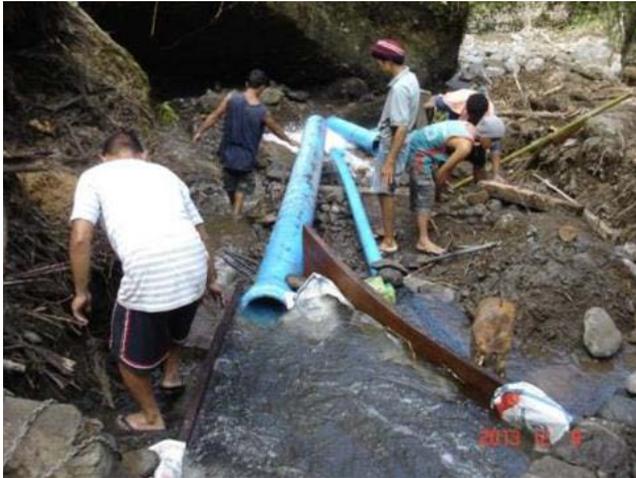
<p>The water district made short-term repairs to the newly exposed transmission pipes, but they remained vulnerable to future storm events.</p>

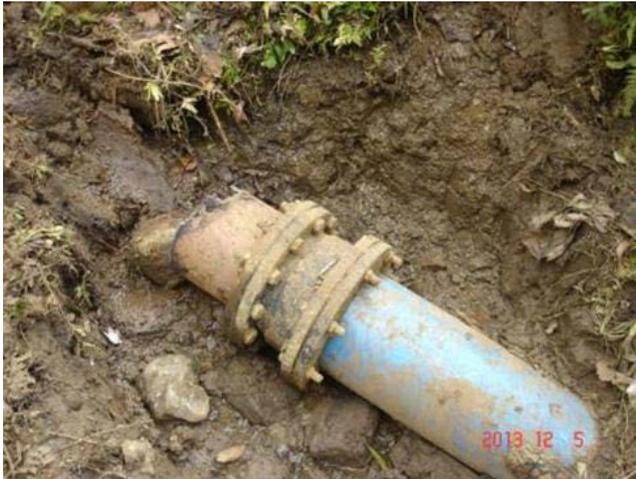
<p>Landslides and flooding exposed and damaged this metal pipe.</p>

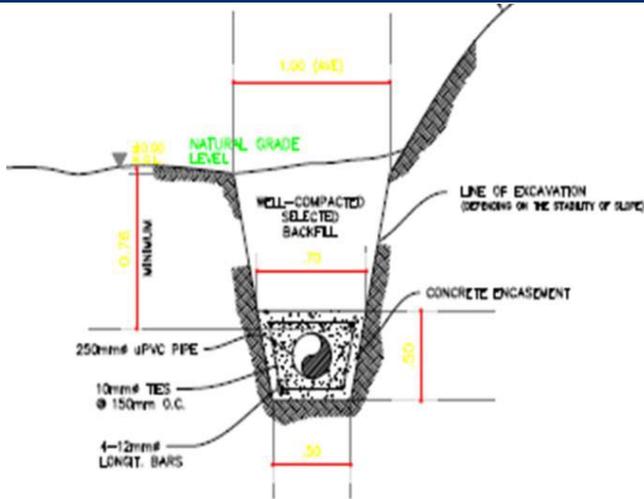
Be Secure developed engineering designs to entrench the pipe and encase it in concrete.

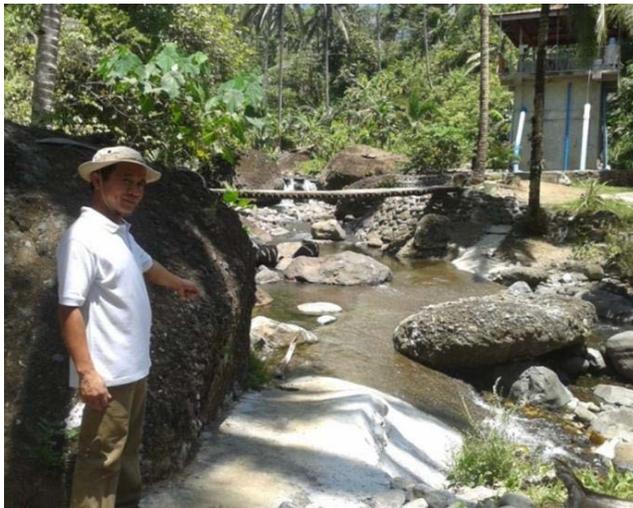
The pipeline was adequately buried and fully encased with reinforced concrete.

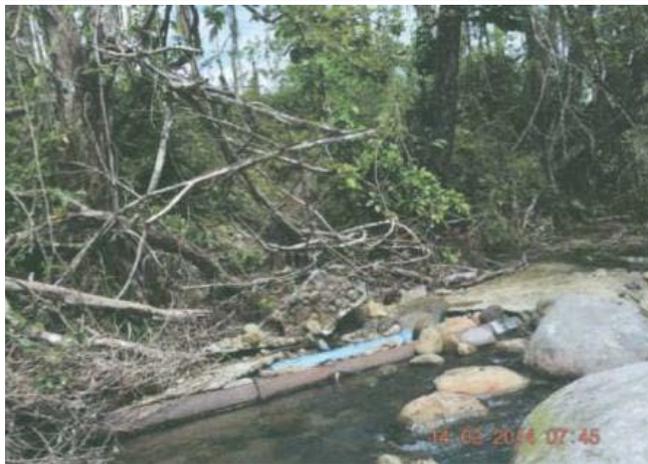
Damaged Transmission Pipe

Metro Carigara Water District maintains a set of parallel transmission pipes from its river source.

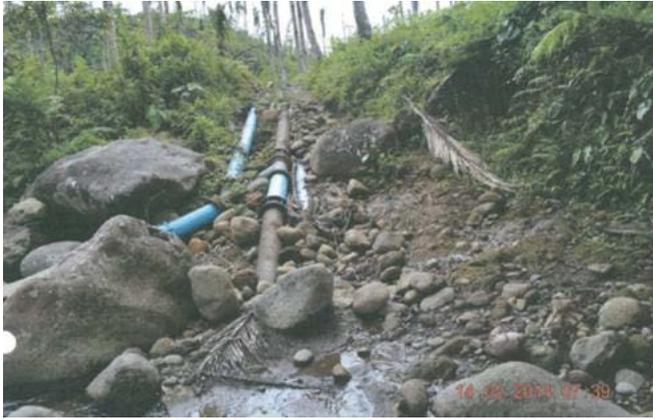
Approximately 250 linear meters of parallel pipelines were damaged during Typhoon Yolanda.

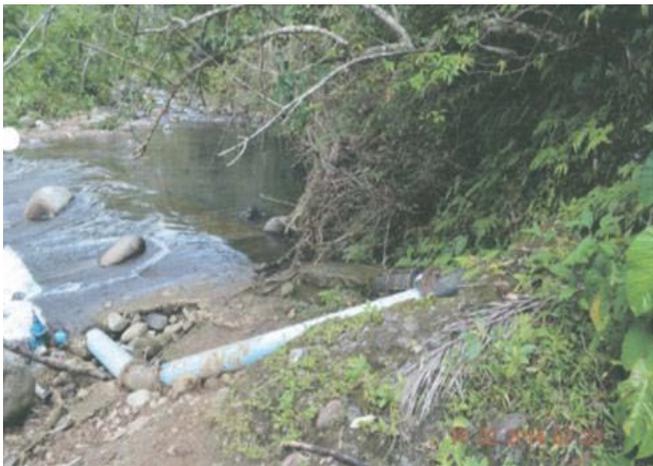
The water district made temporary repairs following the disaster, but the transmission pipe remained exposed along the steep and unstable river bank.

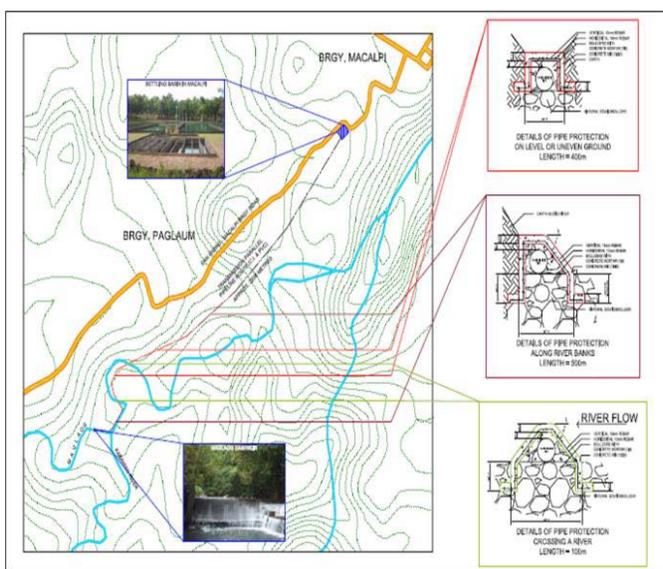
Be Secure developed engineering designs to strengthen the pipelines by encapsulating the pipe with reinforced concrete. The size and shape of the encasement varied along its length depending on the morphology of the river basin. This required detailed site assessments to map and measure the pipeline path along the river.

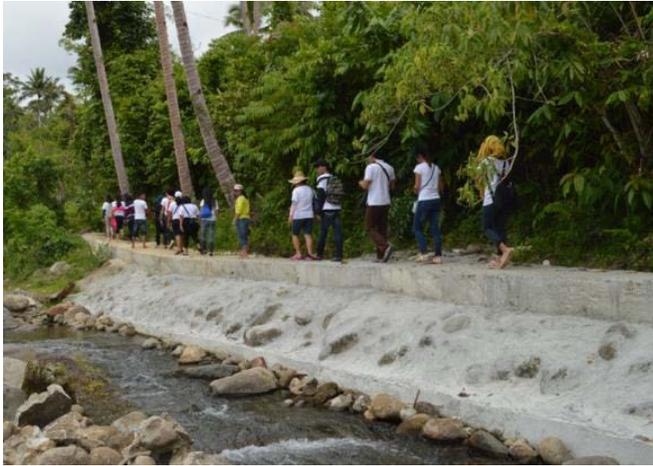
Aside from protecting the pipelines, the above-ground concrete encasement is used as a pathway by local residents.

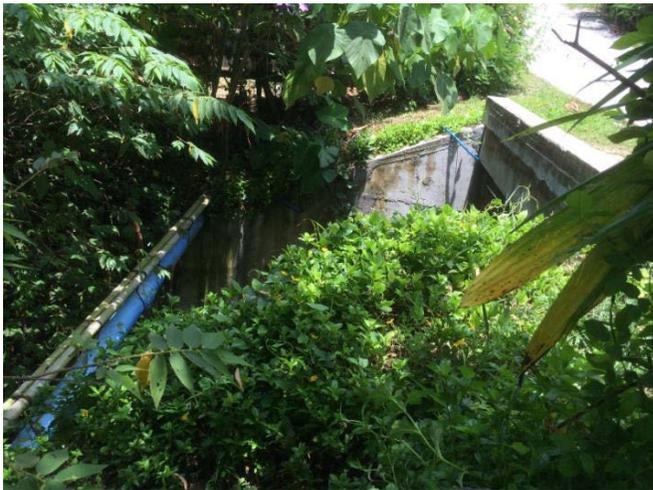
Damaged Transmission Pipe

The transmission pipe for the Isabel Water District crosses the river at two different points. Both of these river crossings make the transmission pipe vulnerable to flooding during storm events.

In addition, the position of the pipe far below the soffit of a neighboring box culvert makes it further exposed to risks of damage.

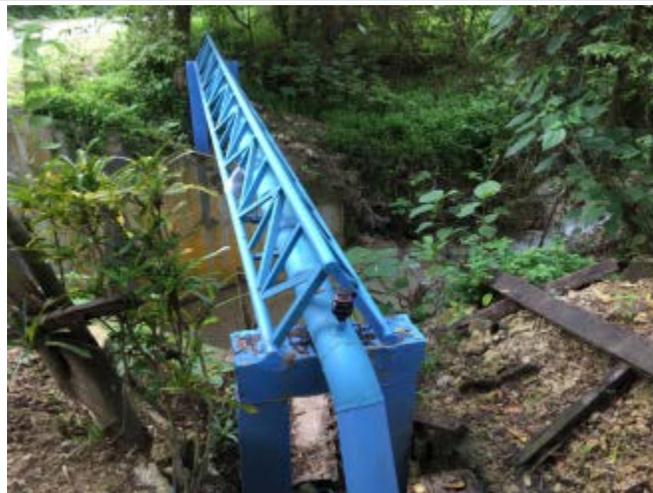
Be Secure re-engineered the section of pipe crossing the river to raise it to the same elevation as the soffit of a newly repaired box culvert.

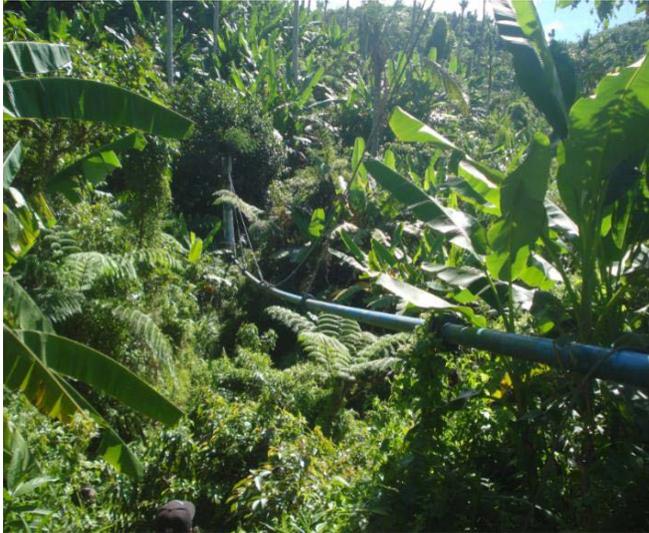
Hanging Transmission Pipe Damaged by Typhoon Yolanda

Kananga Water System has a 75 mm diameter galvanized iron (GI) pipe suspended by vertical cable wires to a parabolic cable across a river spanning approximately 40 m. Some of the cables snapped during Typhoon Yolanda, leaving the pipe hanging precariously.

The wind speed considered in the design is 315 kph, the recorded wind speed of Typhoon Yolanda. This wind speed is higher than the current design requirement of the 2010 National Structural Code of the Philippines, which is 200 kph for Leyte.

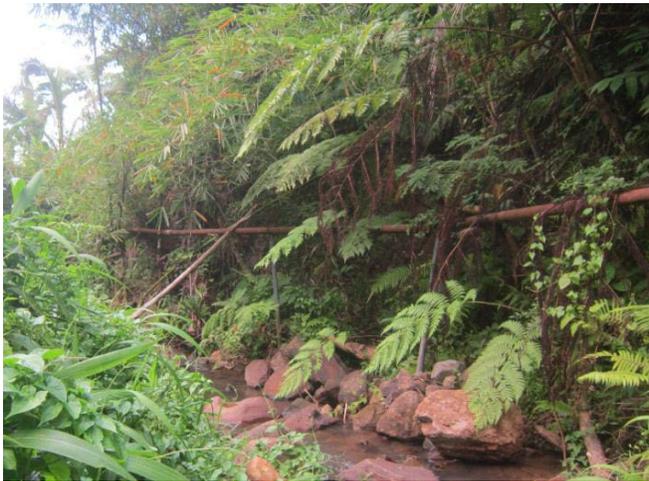
Vulnerable Pipe Near a Slope Prone to Landslide

A portion of the transmission pipe of Kananga Water System is mounted on the side of a slope prone to landslides, making it vulnerable during storms or floods.

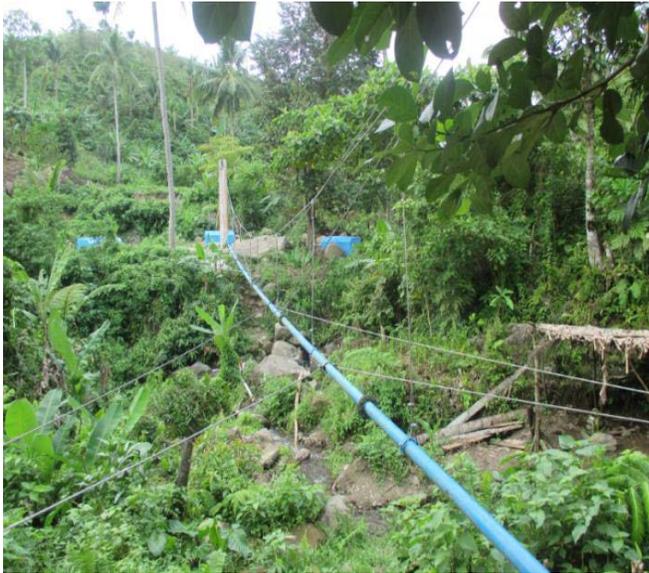
The key is to hold the hanging pipe in place and prevent it from swaying during typhoons. To achieve this, Be Secure placed horizontal stay cables at four points along the pipe. These cables were anchored to reinforced concrete blocks constructed along the river banks. The design calls for a 14 mm diameter stranded stainless steel cable with a minimum breaking load of 173 kilonewtons. Stainless steel was selected because it doesn't require painting/maintenance works, and is ideal for structures where access is a challenge such as the location of this pipe. While the stranded stainless steel cables are more expensive than ordinary steel, they are cost effective because they are corrosion resistant and do not require maintenance. Design wind speed is 315 kph, the same strength as Typhoon Yolanda.

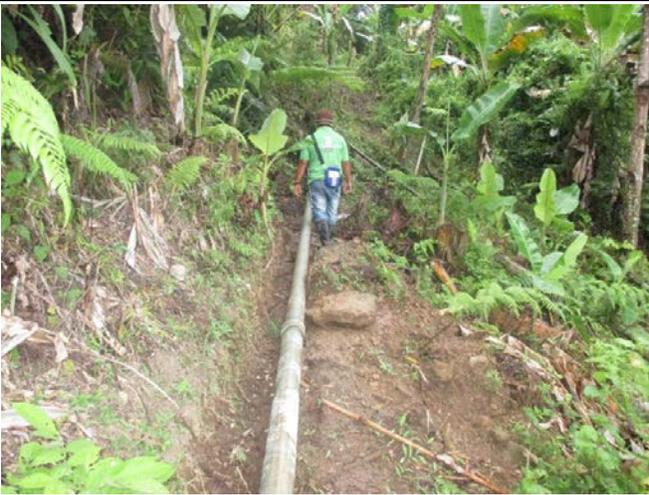
Pipe along the steep hillside was embedded in stable ground.

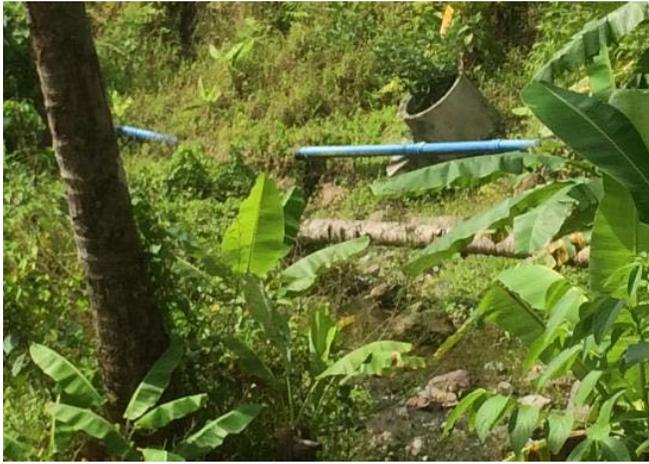
Damaged Transmission Pipe

A portion of the transmission pipe of MacArthur LGU Water System hangs precariously near a river bank. The pipe is vulnerable to flooding.

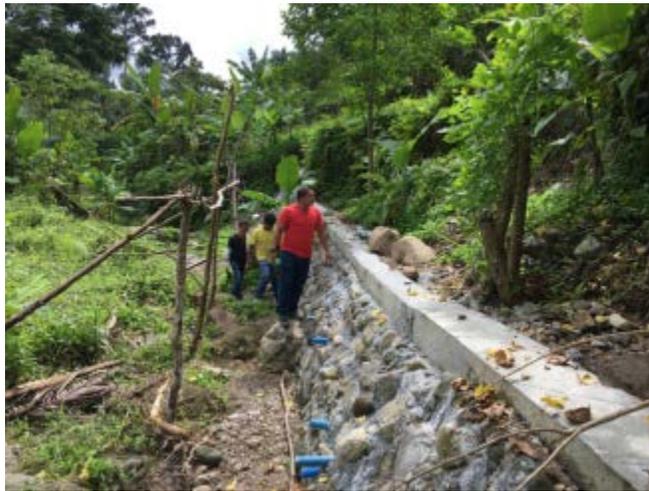
Designs show how the pipe was lowered and encapsulated in reinforced concrete.

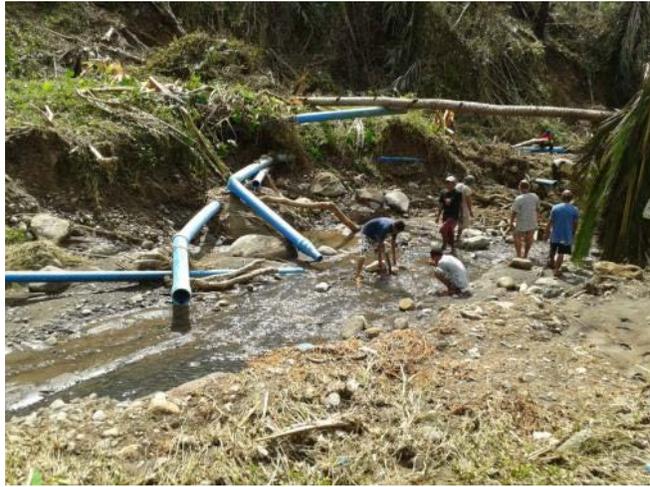
Damaged Exposed Transmission Pipe

Ormoc LGU Waterworks System (OWWS) has a transmission pipe running from its filter plant to its reservoir; about 600 m was damaged by flood waters brought by Typhoon Yolanda disrupting much needed supply during the emergency. The pipe was repaired by the LGU but remains vulnerable as it was simply restored to its original alignment, simply lying on the ground.

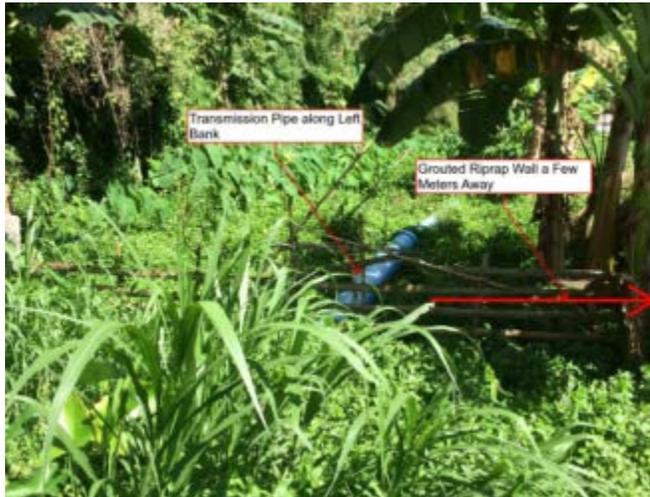
Vulnerable Exposed Pipe Repair

Pipe replacement of OWWS is still exposed and remains vulnerable to inundation

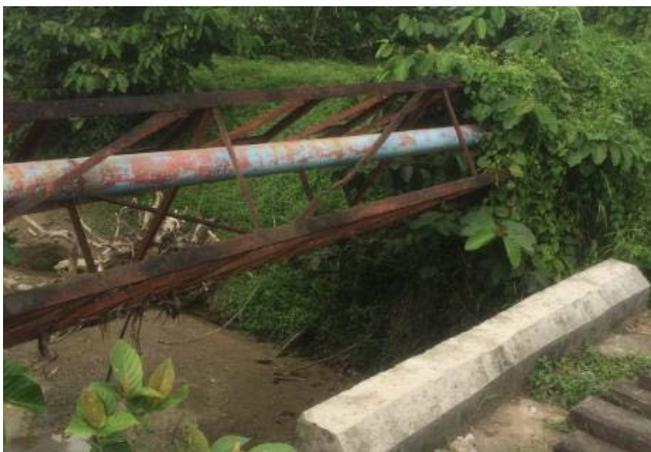
Damaged Pipe Bridge

A 250 mm diameter GI Pipe of San Miguel Water System runs across a creek and is supported by a steel pipe bridge, which in turn is supported by concrete piers on each side. The pipe is about 1 m above the top of a nearby box culvert. However, the box culvert was overtopped by flood waters reaching up to the pipe and damaging the pipe bridge. The pipe was not damaged by the flood waters and the damaged bridge was actually hanging on the pipe.

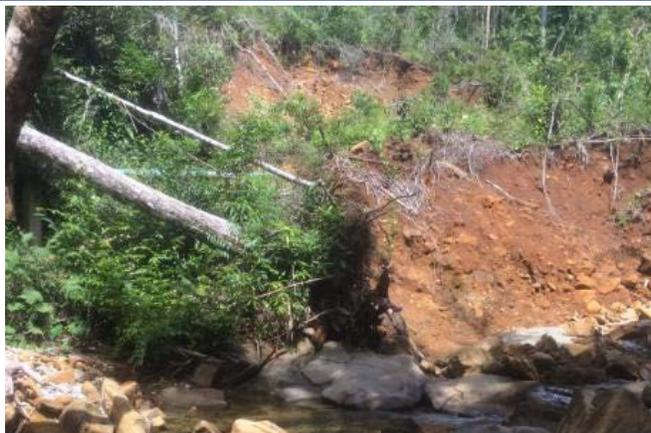
Damaged Raw Water Pipe

Portion of the raw water transmission pipe of San Miguel LGU Water System is supported precariously at the side of a slope prone to landslide. Rains brought by Typhoon Yolanda triggered a landslide that damaged the pipe. The pipe was restored by the LGU along the same alignment which is prone to future landslide

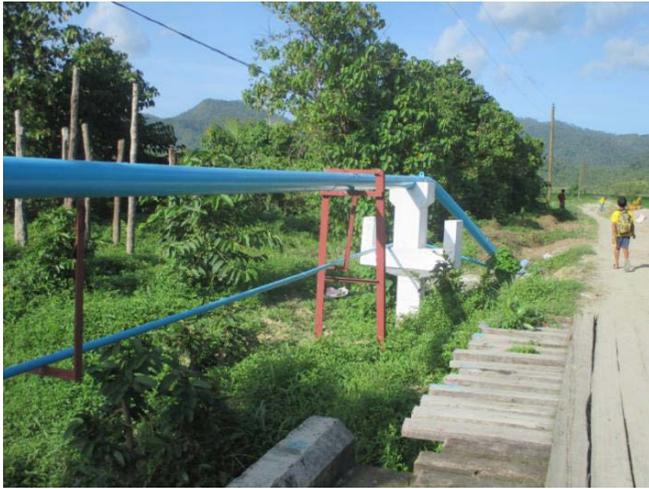
Raised Transmission Pipe Above Flood Level

To minimize disruption of service, a temporary bypass pipe was installed before works on the raising of the pipe began. After taking down the damaged bridge and the pipe, holes were drilled into the top of the bridge pier to accommodate the reinforcing bars for the extension. Chemical anchors were used to ensure bond between the old structure and the reinforcing bars. After extending the concrete piers by 1 m, the pipe was reinstalled. There is no need for pipe support as the pipe was computed to be capable of carrying its own weight.

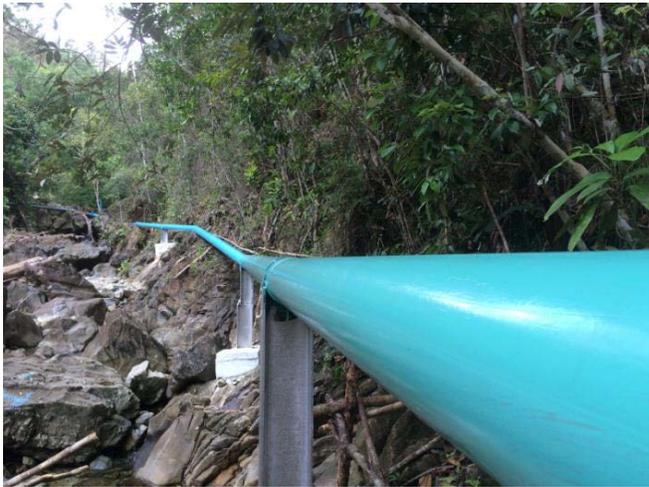
Realigned Transmission Pipe Along the Stable Bank of the River

New transmission pipe installed on the left bank of the river where there is rocky formation. The transfer of the pipe was strongly recommended by the local Mines and Geosciences Bureau (MGB) who confirmed that the right bank is very prone to landslides.

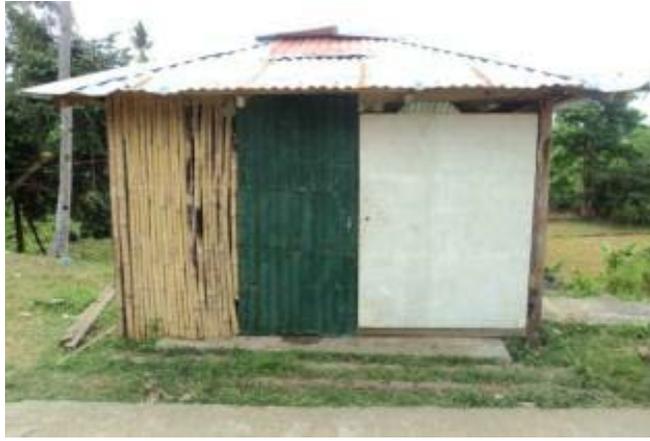
Vulnerable Pump Shed

Isabel Water District has three pumps with sheds. The roofs and wall cladding were made of light materials and were blown away by Typhoon Yolanda and causing operation to stop for days. Temporary repairs were carried out by the LGU but the pump sheds remain vulnerable to high winds during typhoon events.

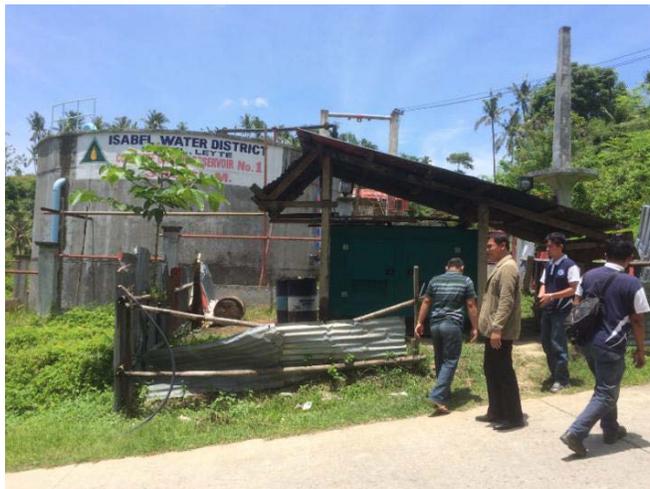
Vulnerable Generator Shed

Isabel Water District has one emergency generator. But as with the pump sheds, the generator shed remains vulnerable to high winds during typhoon events.

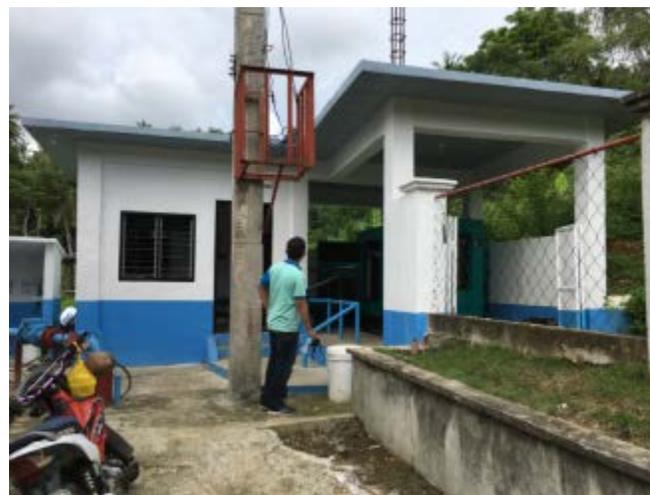
Reinforced Concrete Generator Shed

GI roofing was replaced with reinforced concrete roof deck. The building envelope replaced with concrete masonry.

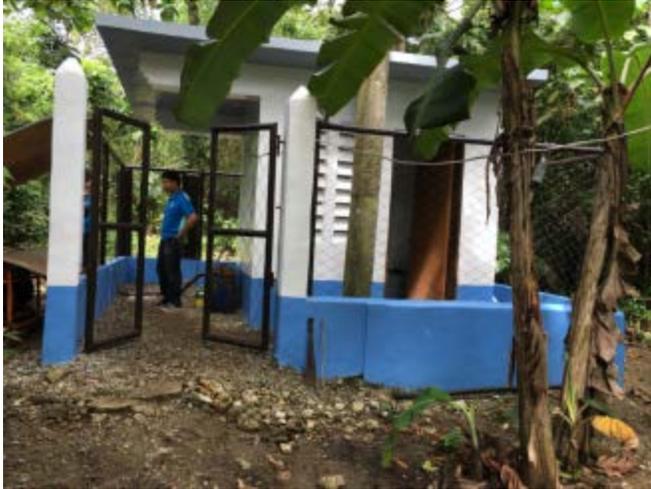
Reinforced Concrete Pump Shed

GI roofing was replaced with reinforced concrete roof deck. The building envelope replaced with concrete masonry.

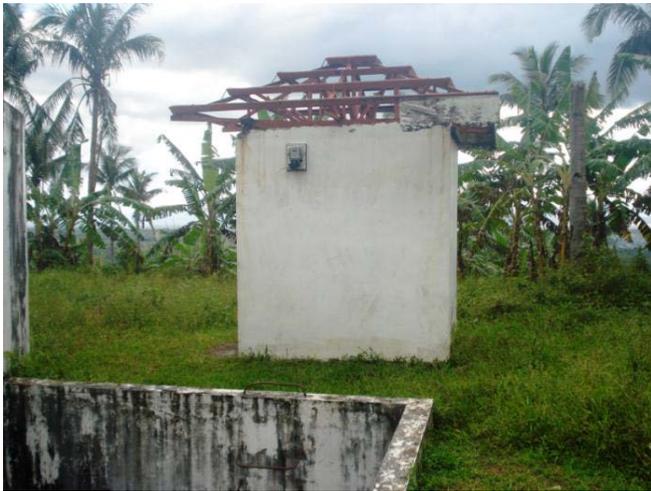
Vulnerable Chlorinator Shed

The roofing of the chlorinator shed of Kananga LGU Water System is made of GI sheets. The GI sheets were blown away by strong winds brought by Typhoon Yolanda.

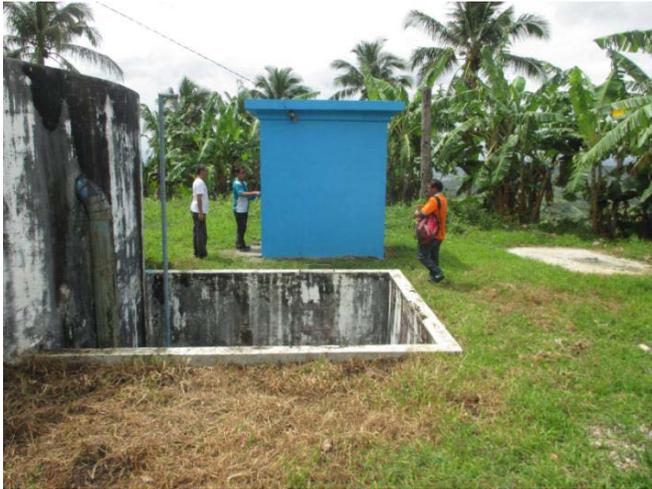
Chlorinator Shed with Concrete Roof

GI roofing was replaced with concrete roof slab.

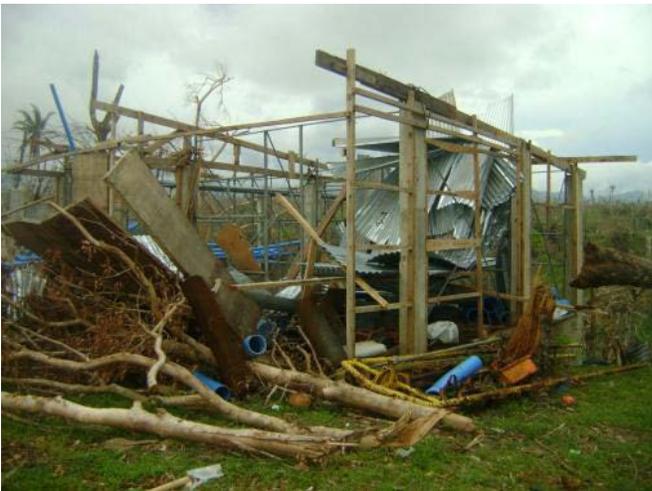
Vulnerable Pump/Generator Shed

Ormoc LGU Water System (OWSS) has several Pump Sheds and Generator Sheds damaged by Typhoon Yolanda . The roofs and wall cladding were made of light materials and were blown away by Typhoon Yolanda disrupting much needed operation during emergency.

Make do repairs were carried out by the LGU but the sheds remain vulnerable to high winds during typhoon events.

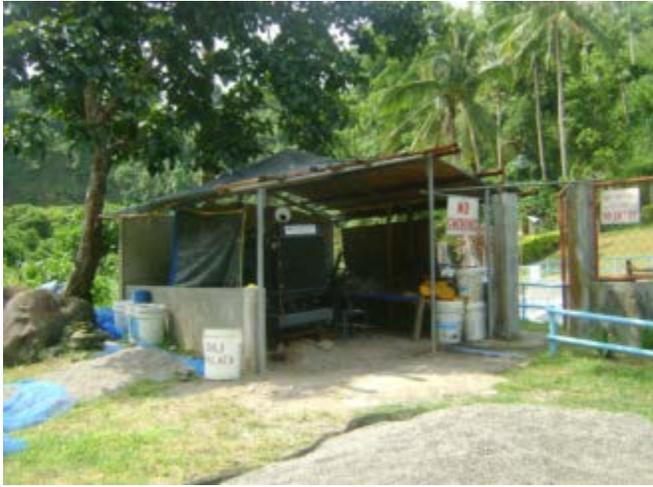
Vulnerable Shed Repair

Makeshift repair of generator shed by OWSS leaves the shed vulnerable to strong winds.

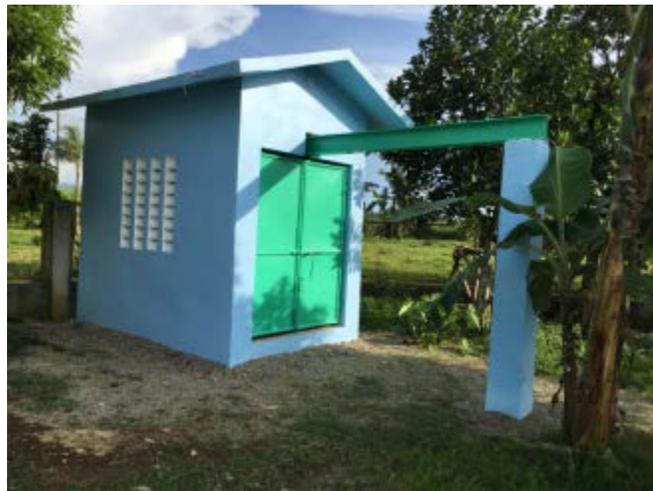
Reinforced Concrete Generator Shed

GI roofing was replaced with reinforced concrete roof slab. The building envelope replaced with concrete masonry.

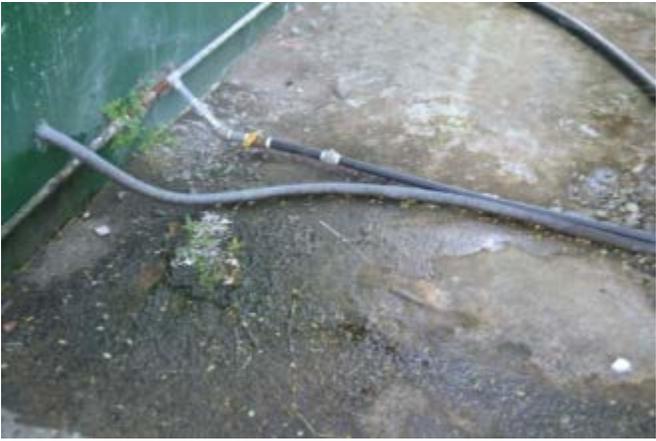
<p>Exposed Pipe Network Vulnerable to Flooding</p> <p>Most schools and health clinics have exposed pipe networks that are vulnerable to flooding. The exposed pipes are also prone to tampering.</p>

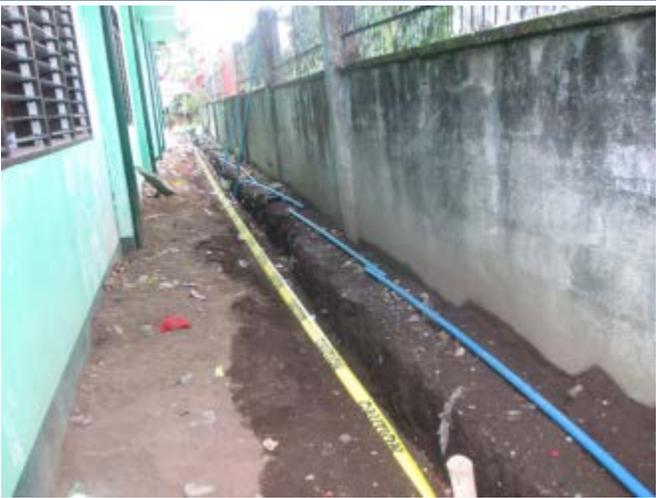
<p>Newly Installed Pipes Fully Embedded</p> <p>Newly installed pipes are fully embedded to be more resilient against flooding.</p>

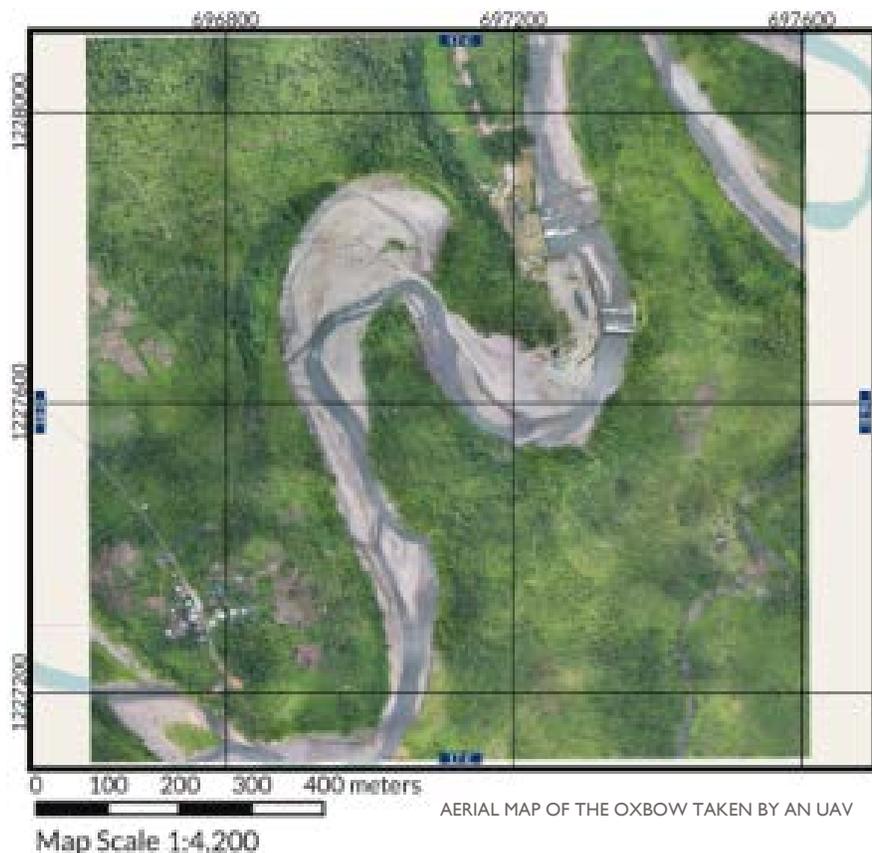
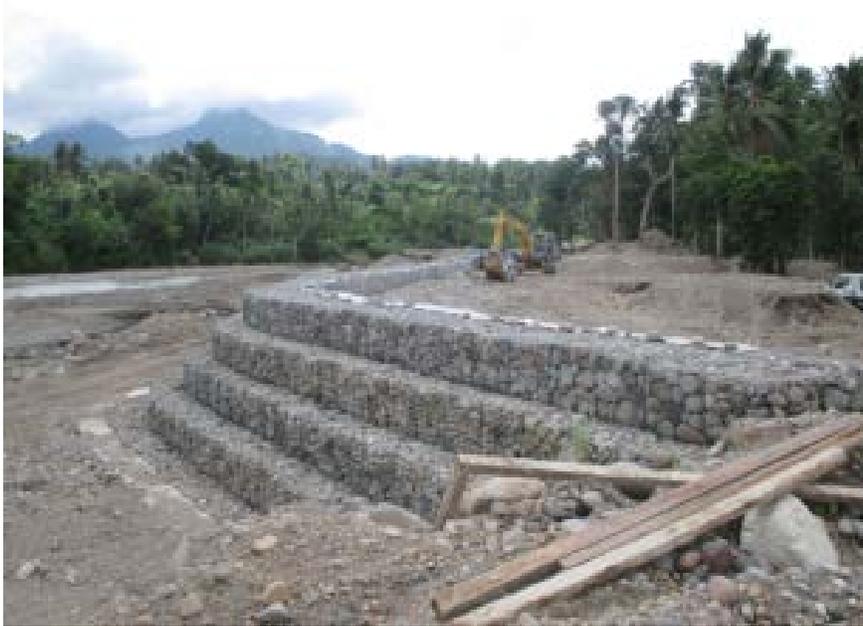
SHORT TERM MITIGATION BEING IMPLEMENTED BY LMWD BASED ON BE SECURE'S DESIGN

- a) For short term implementation
 - Civil design drawings to provide protection to the oxbow (currently being implemented)
 - Civil design drawings to provide protection to the critical section downstream of the oxbow (currently being implemented)
 - Civil design drawings of the stilling basin to protect the diversion weir from scouring (for implementation)
- b) For long term implementation
 - Civil design drawings to increase the capacity of the diversion weir to pass extreme floods (for implementation)

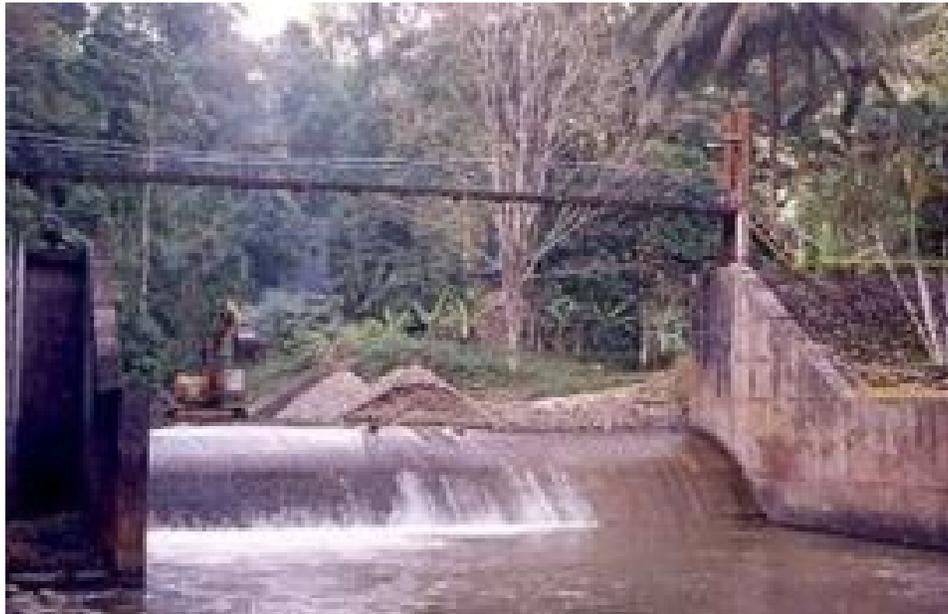
EXISTING SOURCE OF ZCWD IS A DIVERSION WEIR AND NO HOLDING CAPACITY, THUS, WATER IS WASTED DURING RAINY SEASON AND THE WEIR RUNS DRY DURING SUMMER EXACERBATED BY EL NIÑO.

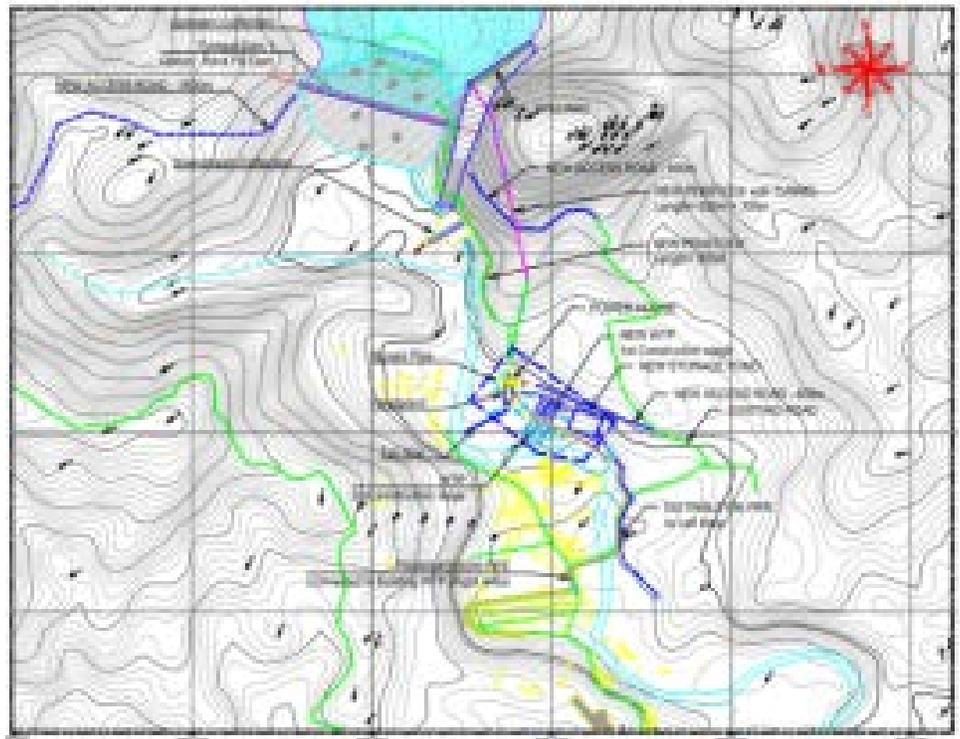
PLAN SHOWING THE EXTENT OF THE 90M HIGH DAM. BECAUSE OF SEISMIC ISSUES, A ROCK-FILL DAM TYPE IS PROPOSED.

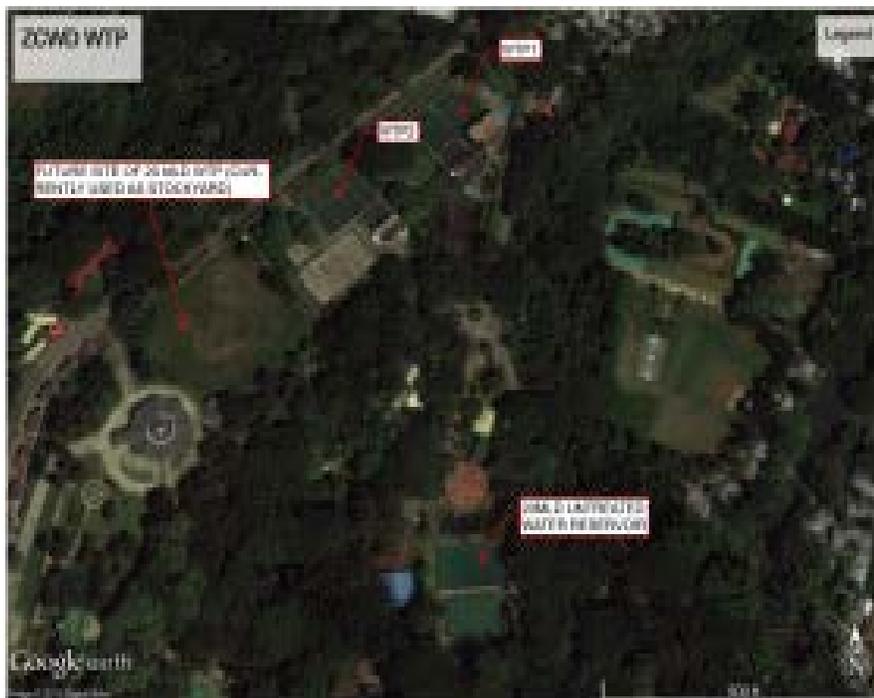
THE PROPOSED LAYOUT SHOWING THE OLD RESERVOIR, THE PUMP STATION, THE NEW 20 MLD WTP AND THE TREATED WATER RESERVOIR

- A pump station near the old reservoir that will pump water to the proposed 20 MLD WTP
- A 20 MLD Conventional WTP that includes automatic backwash and backwash recovery
- A sludge treatment facility that will be sized to include the sludge of the existing WTP
- A treated water reservoir

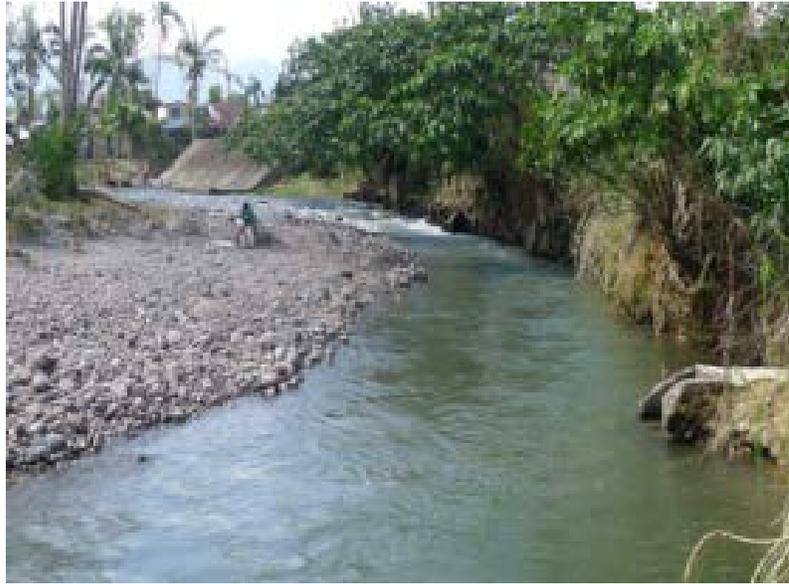
CABAYUGAN RIVER WITH DISCHARGE OF 47-76 MLD

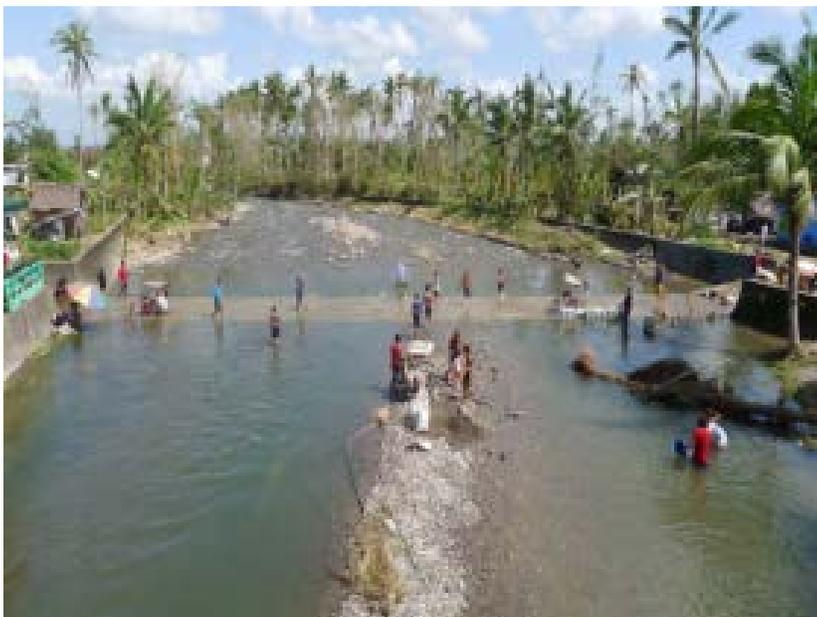
PONGSO RIVER WITH DISCHARGE OF 43-70 MLD

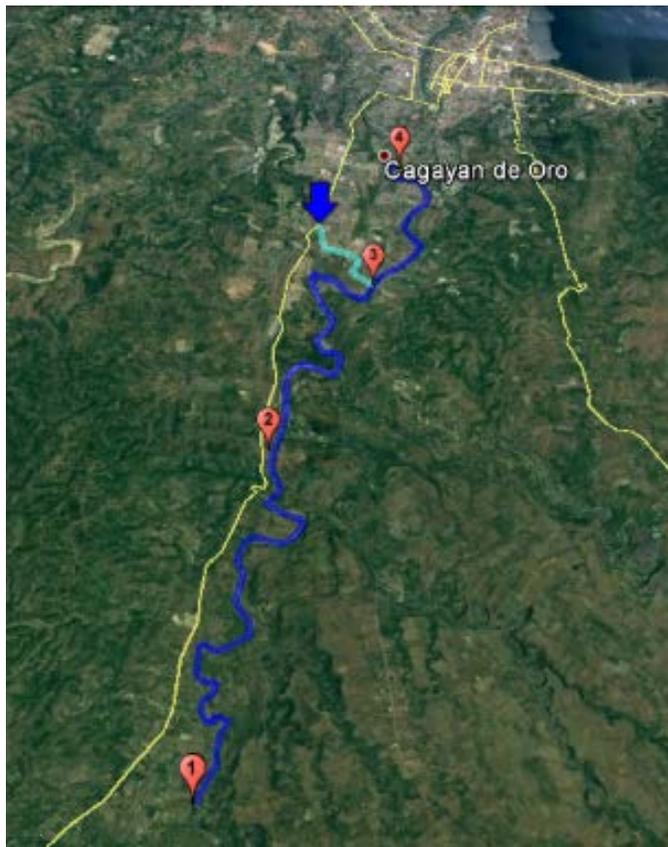
CAGAYAN DE ORO RIVER SHOWING POSSIBLE ABSTRACTION POINTS

The new source will come from Cagayan De Oro River and the extraction point is in Barangay Cabula, upstream of Cabula Bridge. The total capital cost of the above improvements is about Php 2 billion. This includes the bulk water portion and that of the distribution system improvements.

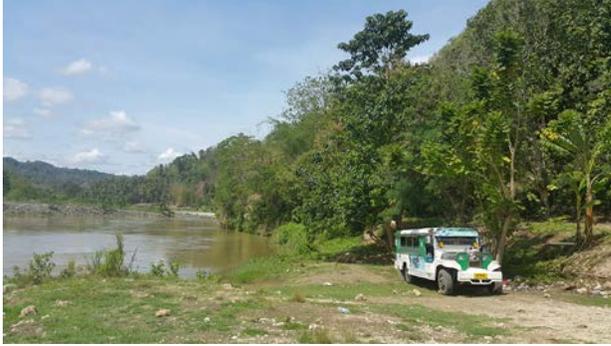
PROPOSED ABSTRACTION POINT AT BARANGAY CABULA
